Job #190296

Real Estate Inspection

CUSTOMER NAME Danielle Kavanagh	ADDRESS 803 Jessie Street, Austin, TX 78704 USA
SYSTEM NAME OR LOCATION Closet	MAKE AND AGE OF SYSTEM Trane 2021
Size of System 3.5	SYSTEM TYPE HEAT PUMP

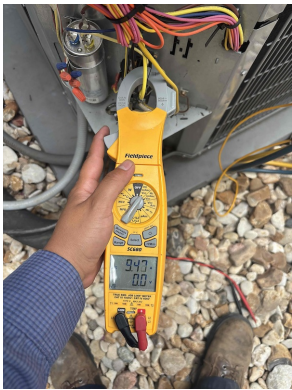
COMPRESSOR AMPS

GOOD

High amps during startup phase.

ADDITIONAL UNITS IF APPLICABLE	JOB NOTES
<p>Reason for upstairs level not cooling very well is due to unbalanced ductwork design and poor attic insulation.</p>	<p>Overall air-conditioning system and cooling home. The upstairs feels hotter due to lack of ductwork design as well poor attic insulation R-value level levels. Air filter is very dirty. It needs to be replaced as soon as possible. There is insulation missing where a line set comes out of slab foundation outside. Refrigerant charge is within range. However is slightly off. Would need around 1 pound of refrigerant. Starting amps on compressor motor are high and exceeding maximum LRA, hardstart kit would be recommended.</p>

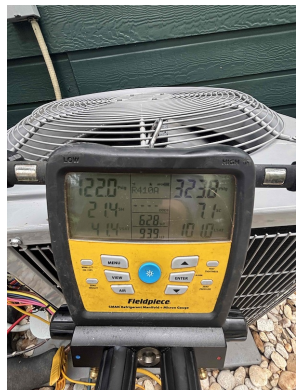
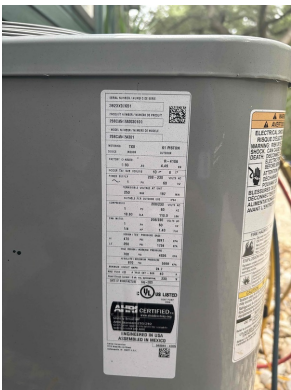
SUPERHEAT AND SUBCOOLING WITHIN RANGE

YES

Subcooling is slightly off, could use 1 pound of 410a

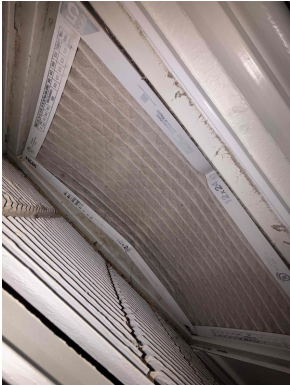
FLOAT SWITCH SHUTS DOWN SYSTEM YES	ADDITIONAL UNITS IF APPLICABLE Only 1 float sensor is installed, needs to have 2 per code.
AIR FILTER CLEAN NEEDS REPLACEMENT

ADDITIONAL UNITS IF APPLICABLE Filter is Very dirty
1" CLEARANCE AROUND FLUE N/A	ADDITIONAL UNITS IF APPLICABLE -
PLENUM SEALED YES	ADDITIONAL UNITS IF APPLICABLE -
DRAIN LINE INSULATED NO

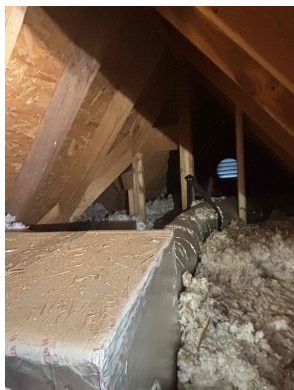
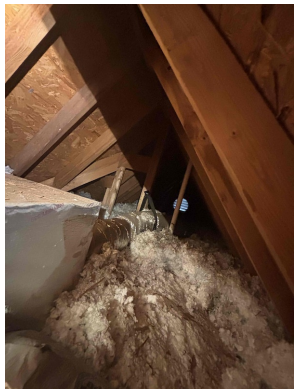
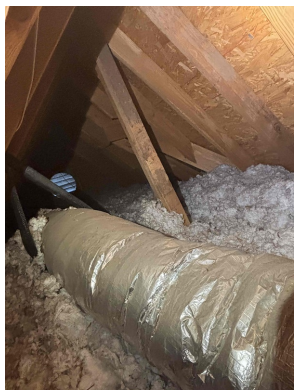
DUCT SYSTEM CONDITION

FAIR
